PERATION

GREENHOUSE

SCIENTIFIC DIRECTOR'S REPORT

ANNEX 3.2 U. S. NAVY STRUCTURES

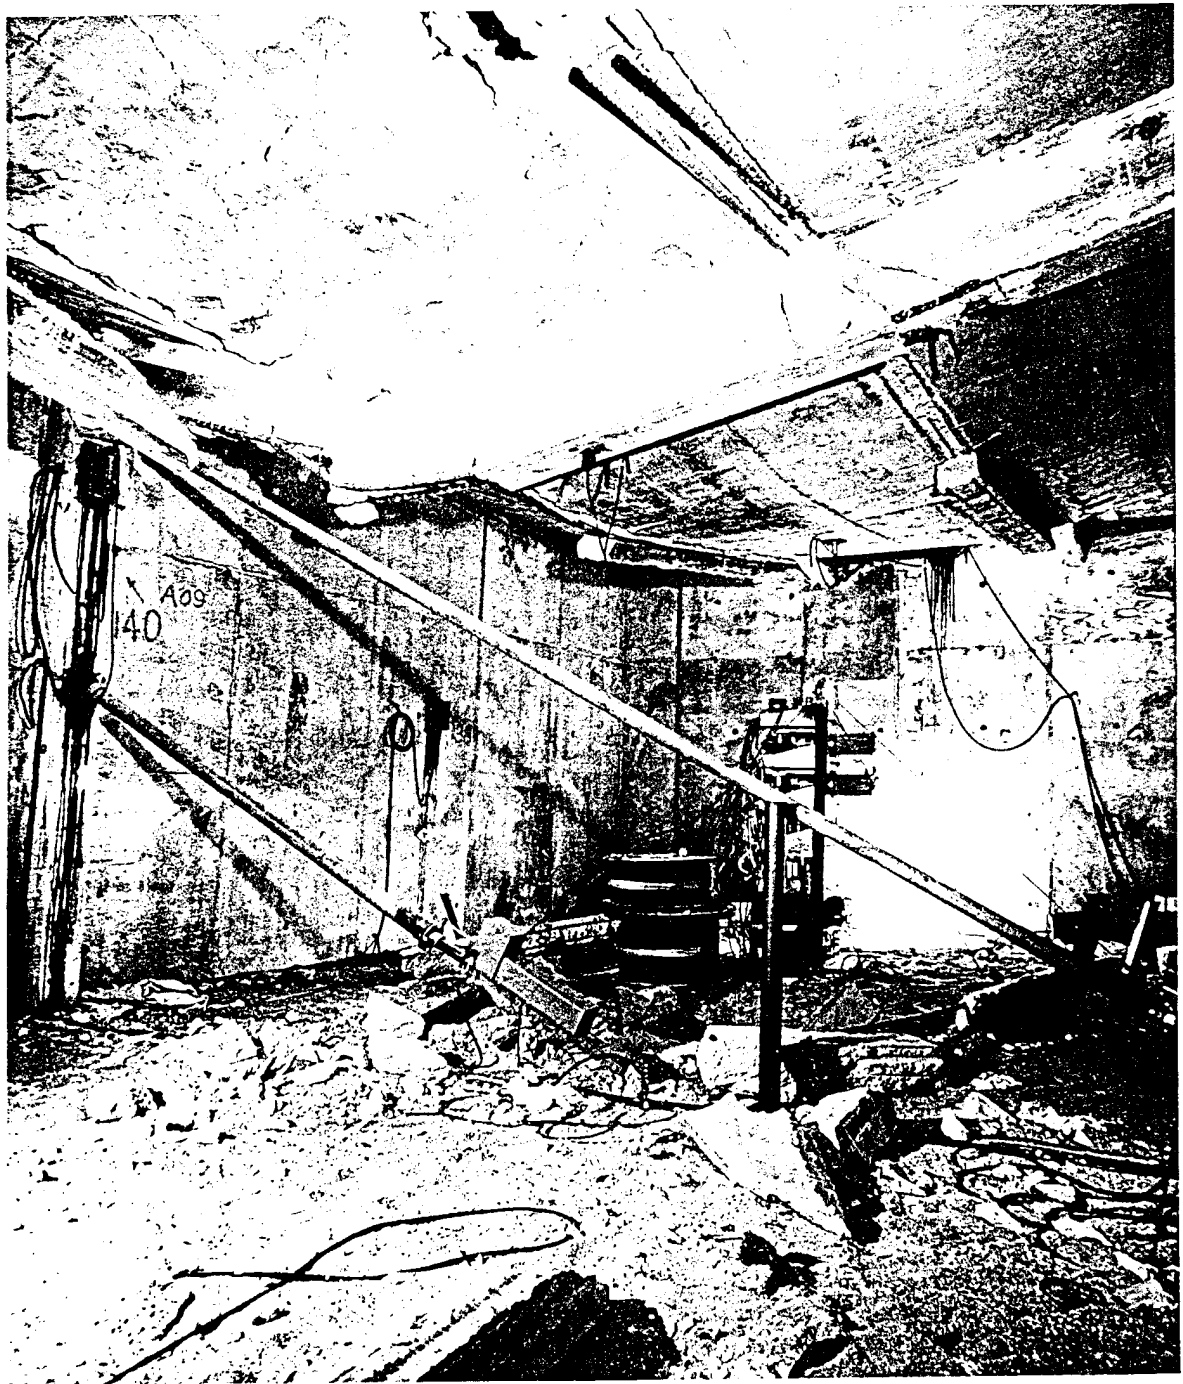
Fig. L. 509 General Interior View Looking toward Left End of Structure, 3.2.7b. Deflection of the main transverse roof girder can be clearly seen. Note the lower sections of the small longitudinal stringer beams lying on the ground below the beams.

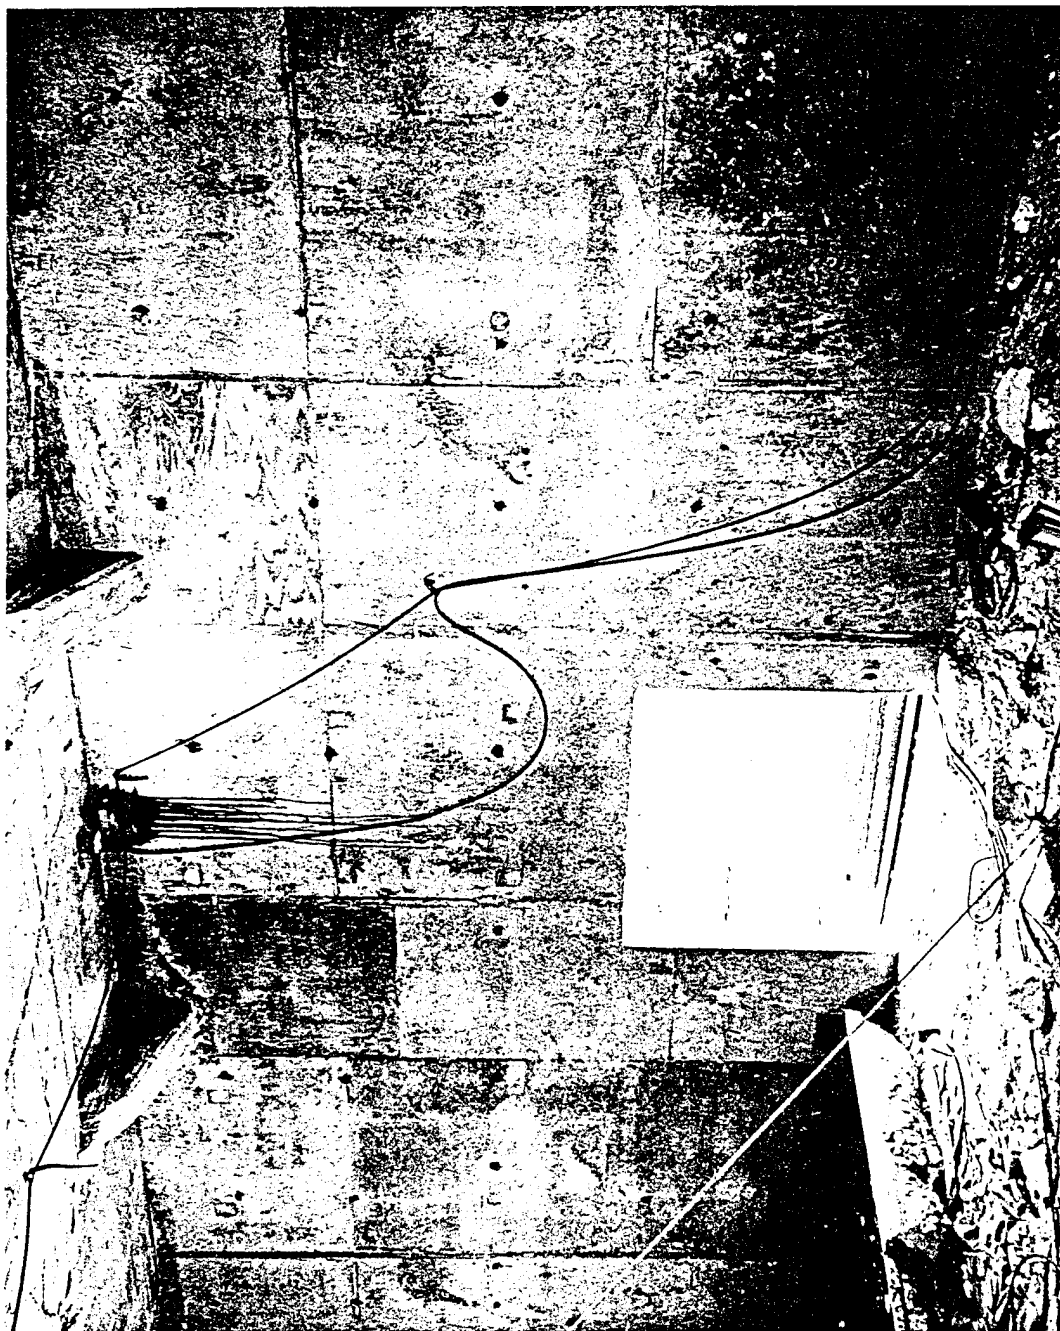
Fig. L. 510 Interior View of Left End Wall, Structure 3.2.7b

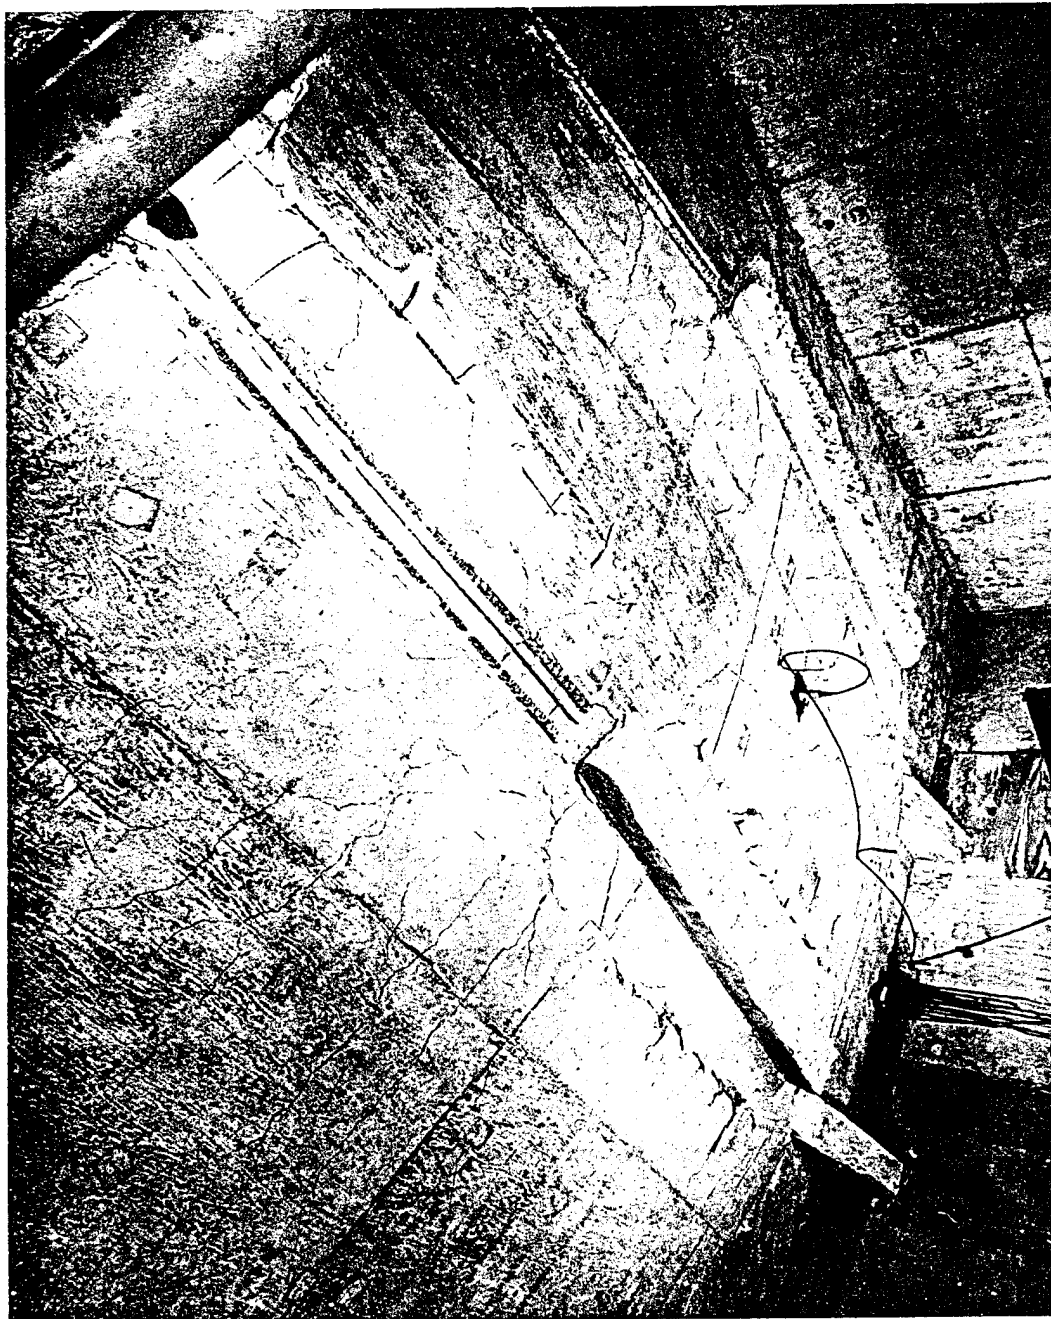
Fig. L. 511 Interior View of Left Half of Underside of Roof, Structure 3.2. 7b. Note how longitudinal stringer beams failed.

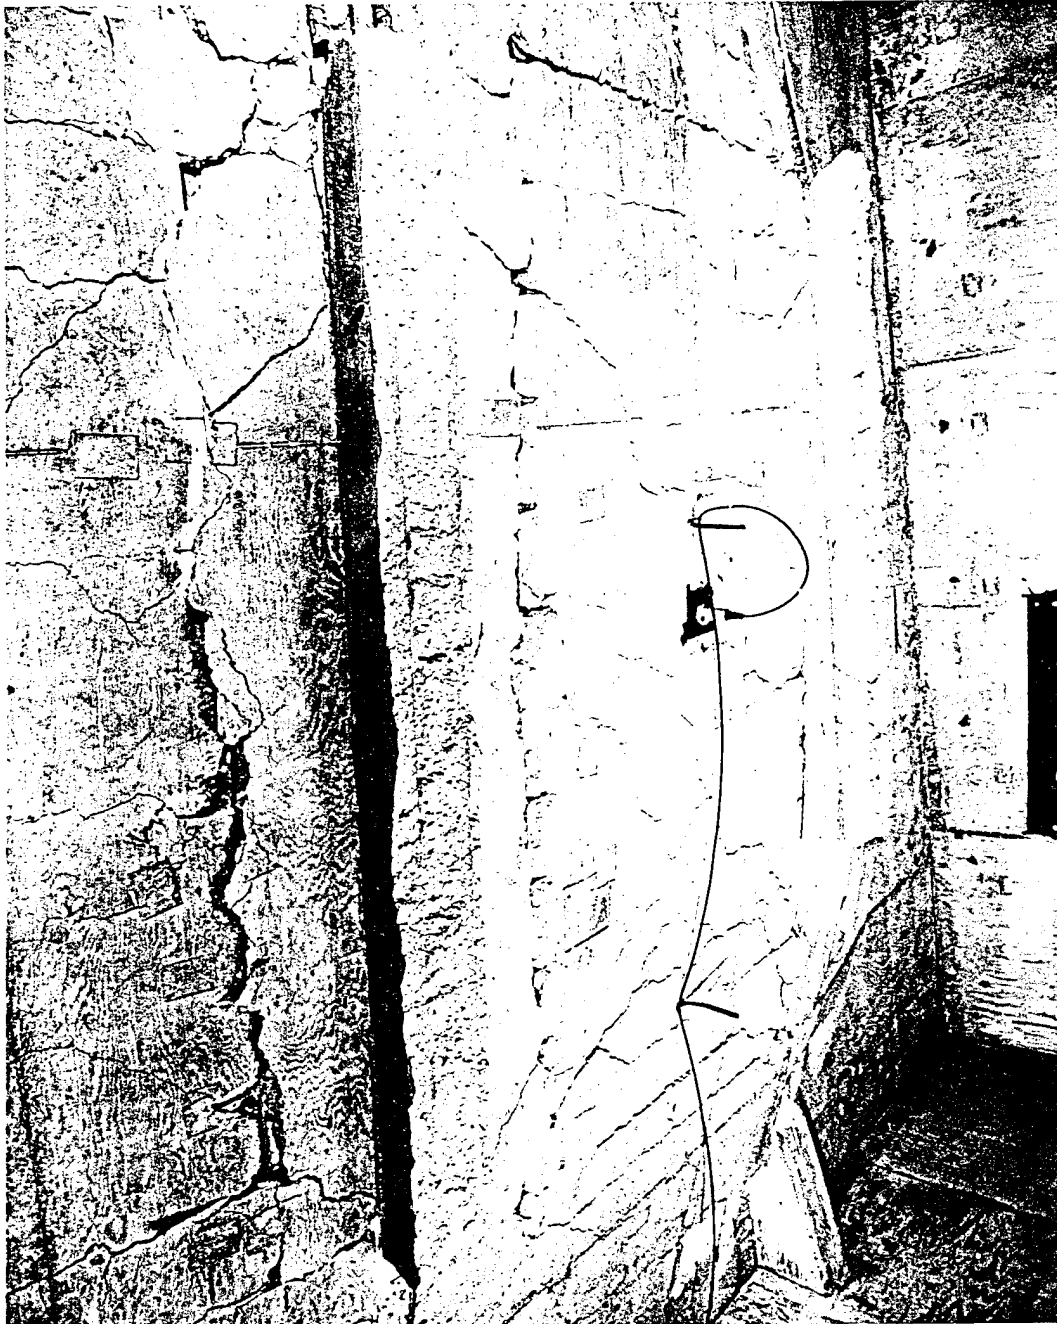
Fig. L. 512 Detail View of Underside of Left Portion of Roof, Structure 3.2. 7b. Note the uniform pattern of cracking in the roof slab proper.

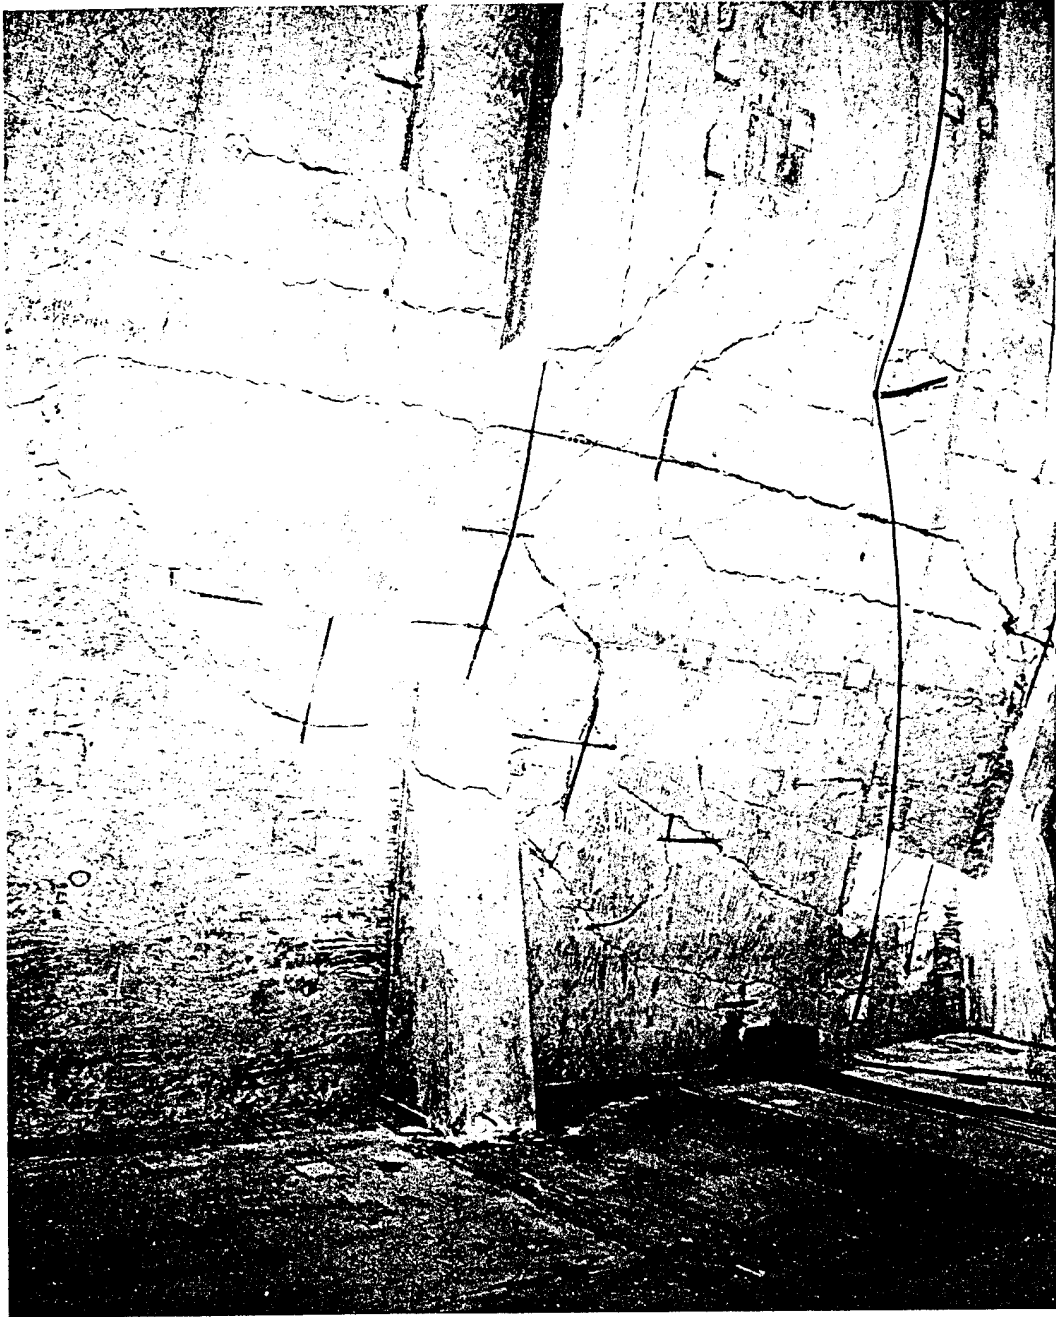
Fig. L. 513 Detail View of Failure of Longitudinal Stringer Beam in Diagonal Tension, Structure 3.2. 7b. There was only a 6-in. overlap of top and bottom steel at the haunch, with no stirrups.

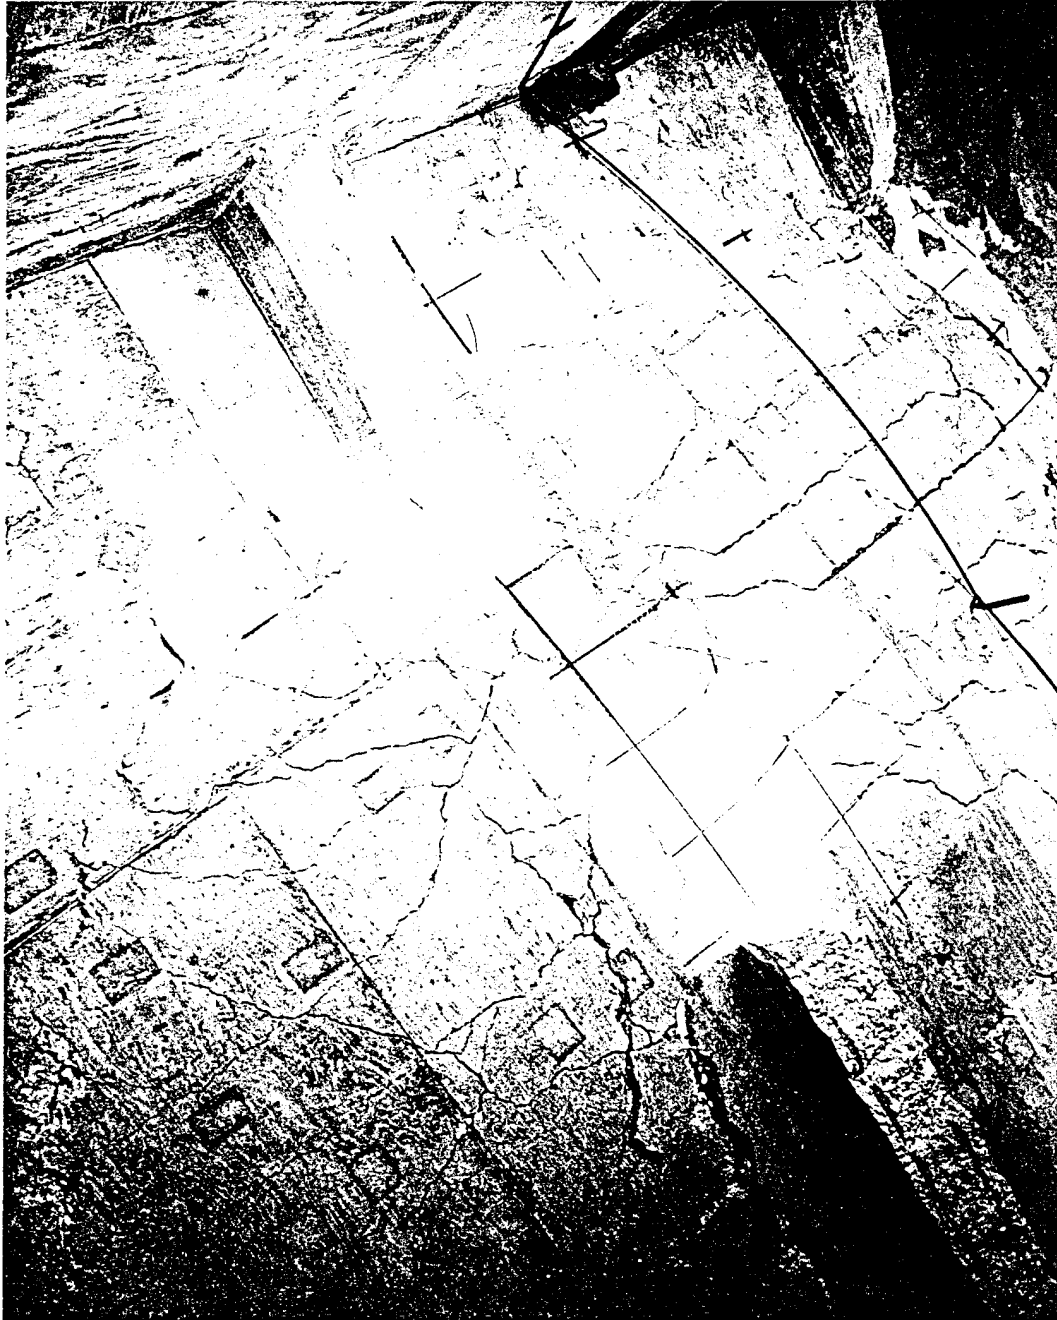
Fig. L. 514 Detail View of Failure of Same Stringer Beams as Shown in Preceding Photographs, Structure 3.2.7b.
Note the clean break through the concrete at the haunch. There was no effective steel tie at this location.

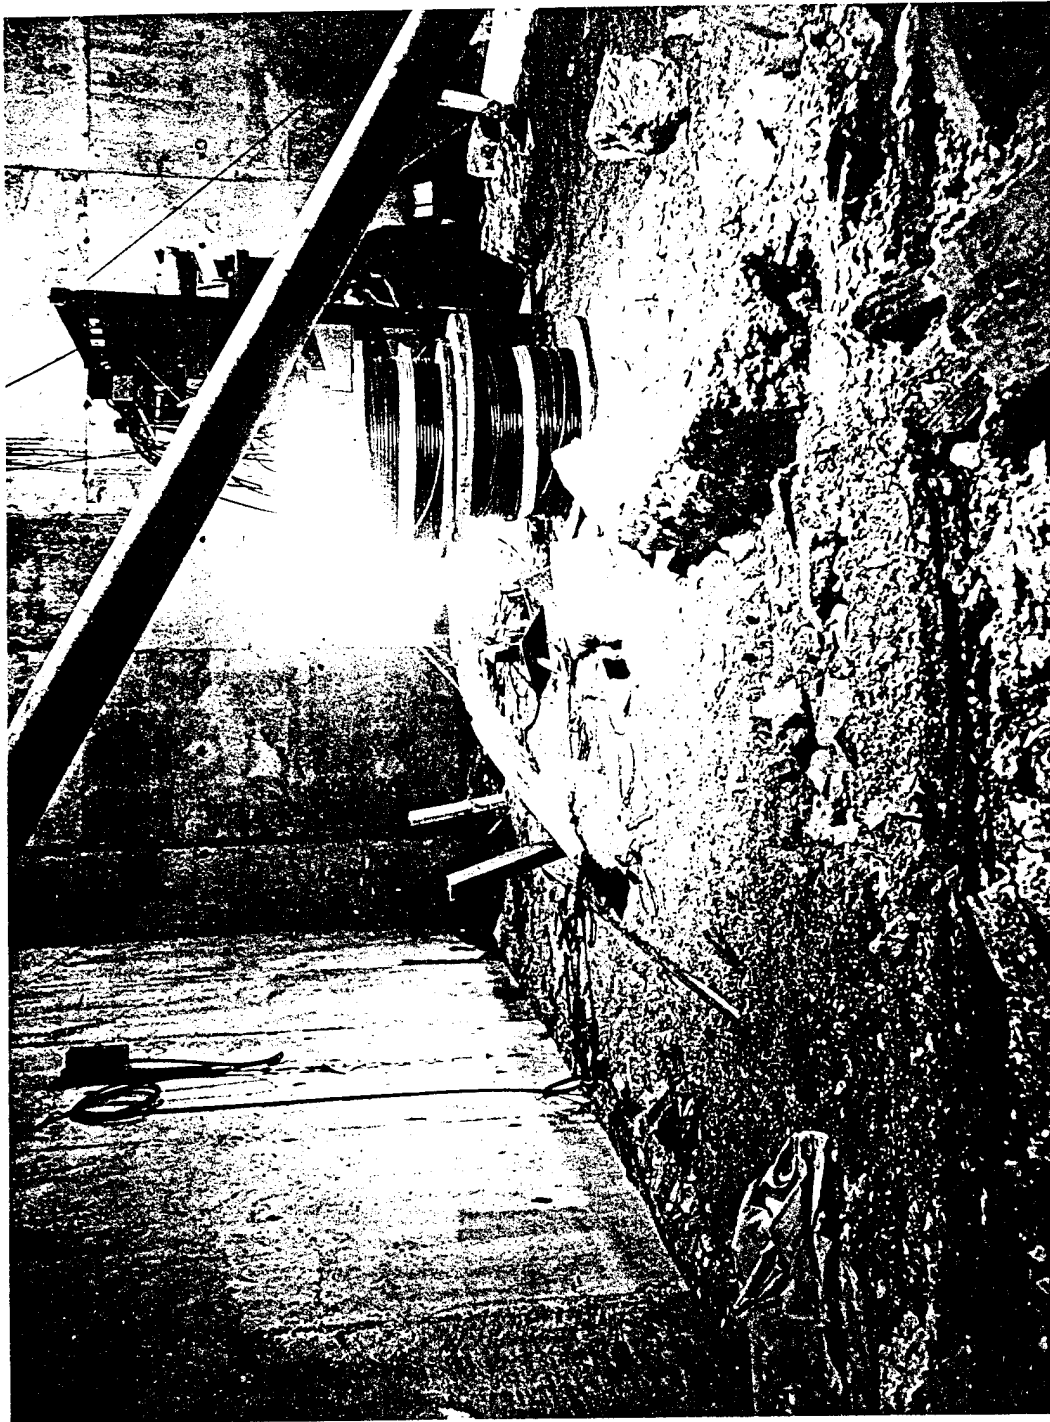
Fig. L. 515 Detail View of Lower Section of Front Stringer Beam in the Left Half of Roof, after This Part of Beam Was Severed from the Roof, Structure 3.2. 7b

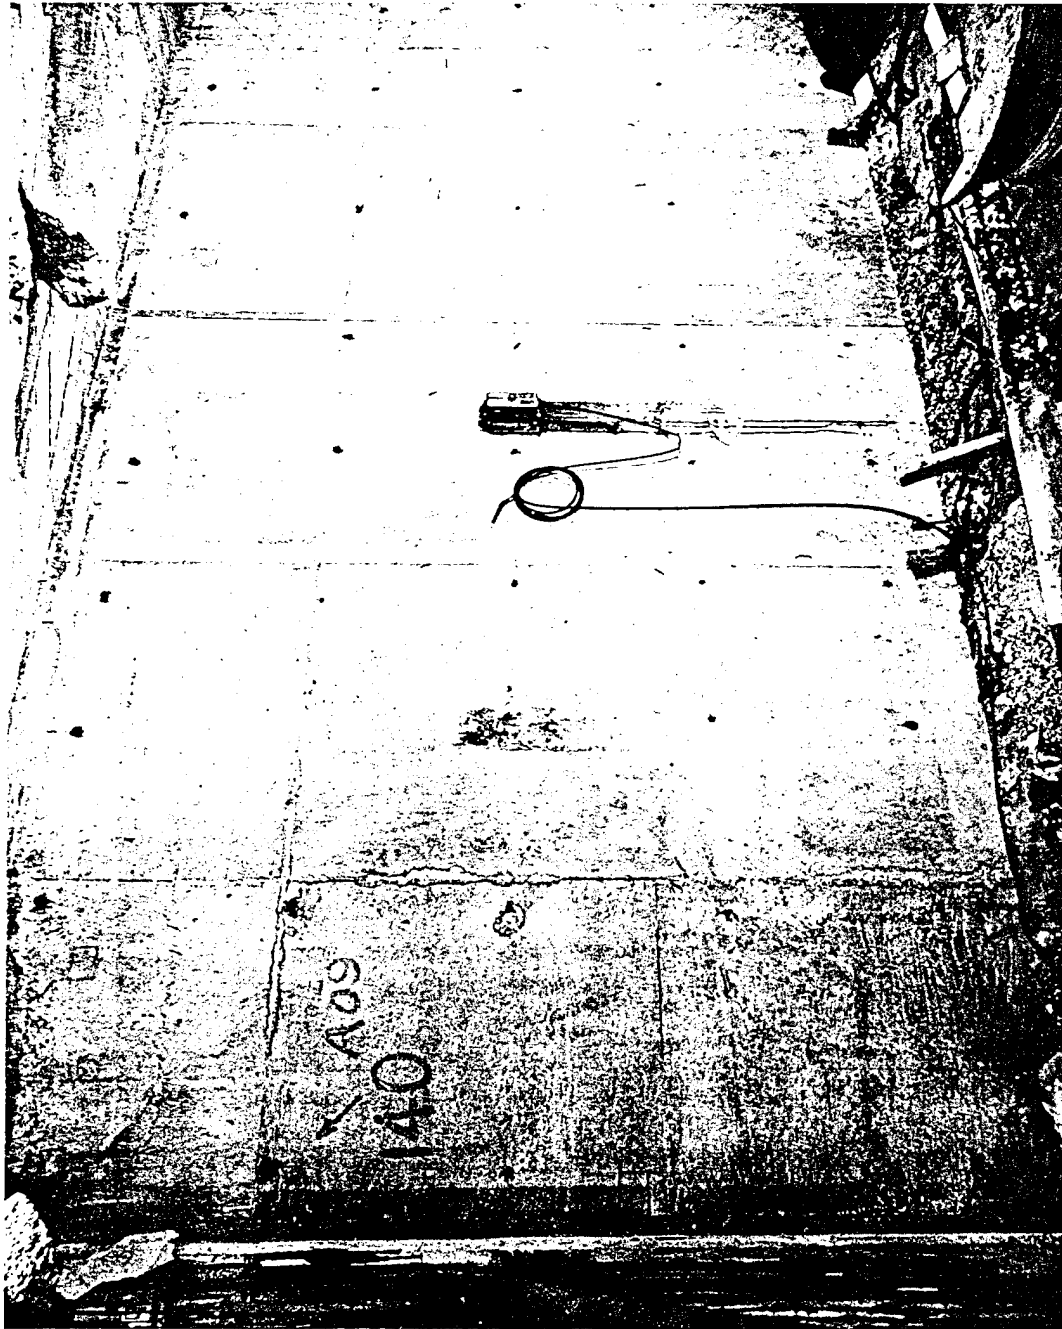
Fig. L. 516 Interior View of Left Half of Front Wall, Structure 3.2. 7b. The clean concrete break of a stringer beam can be seen overhead.

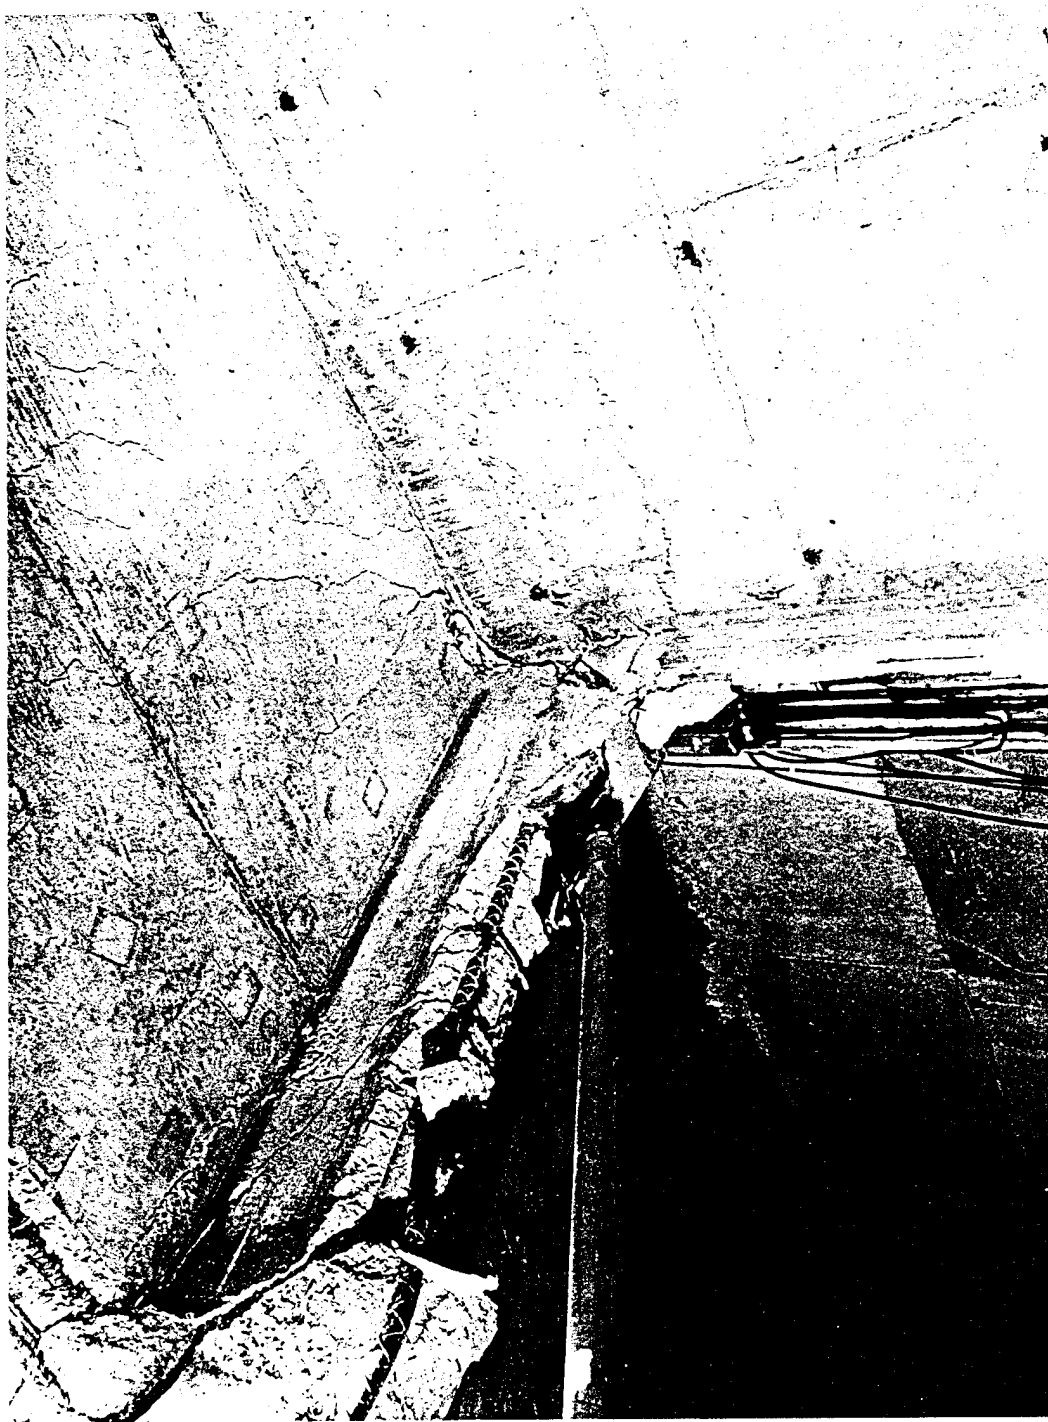
Fig. L. 517 Detail View of Transverse Roof Girder at Front Wall, Structure 3.2. 7b. Haunch failure and girder failure can be clearly seen.

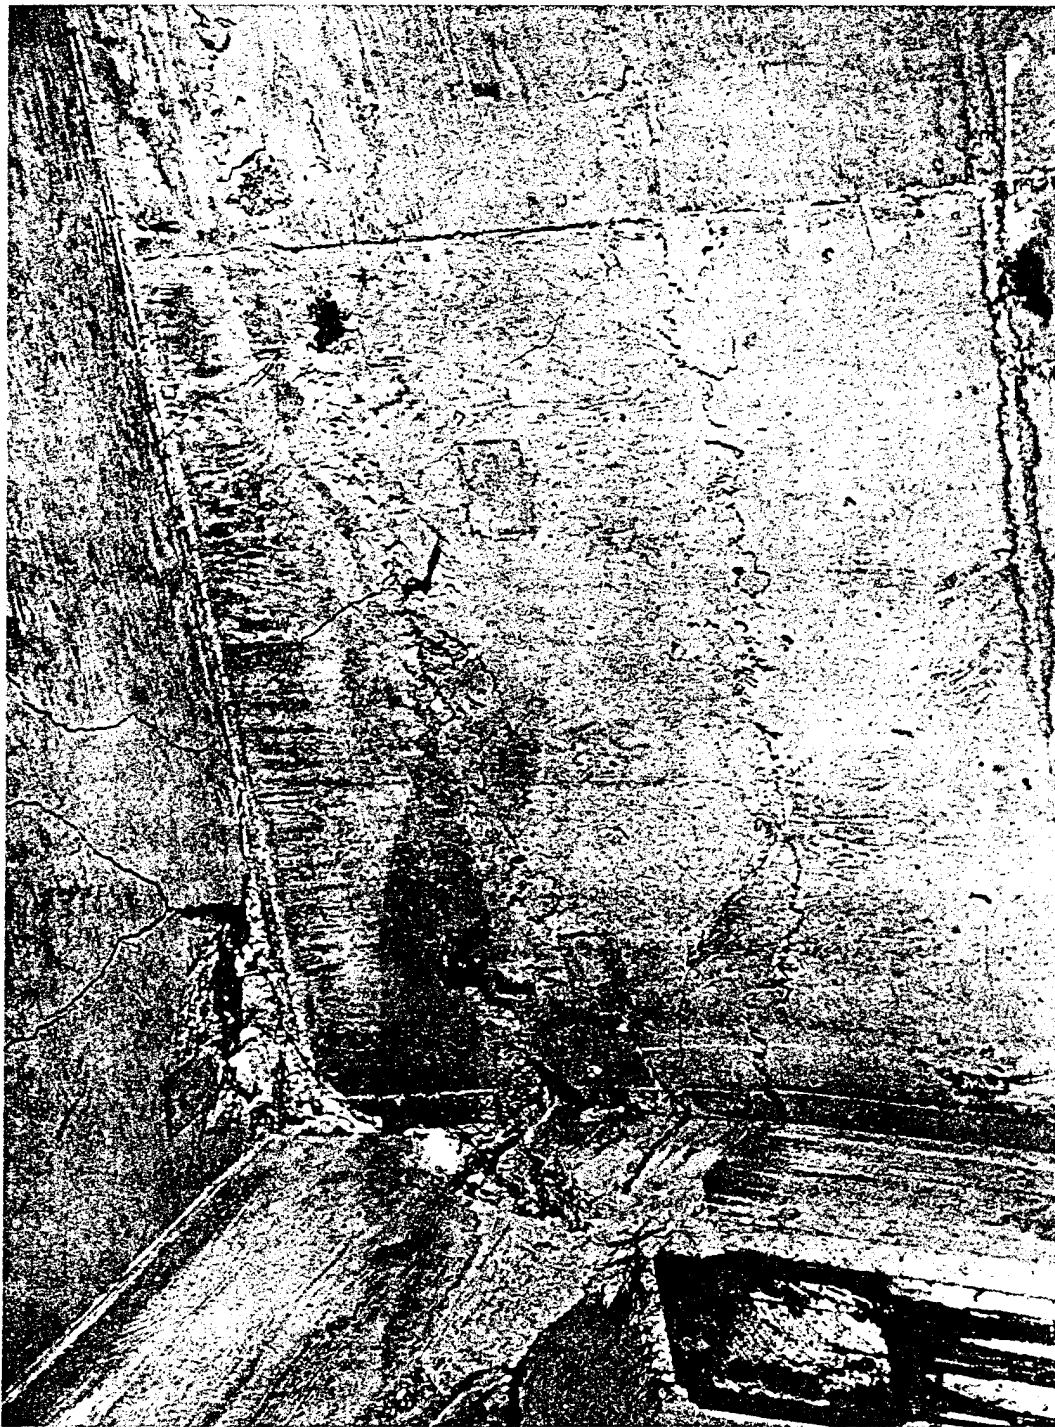
Fig. L. 518 Detail View of Main Girder Haunch at the Front Wall, Structure 3.2. 7b. Note how part of the wall has bent inward with the girder haunch when it rotated.

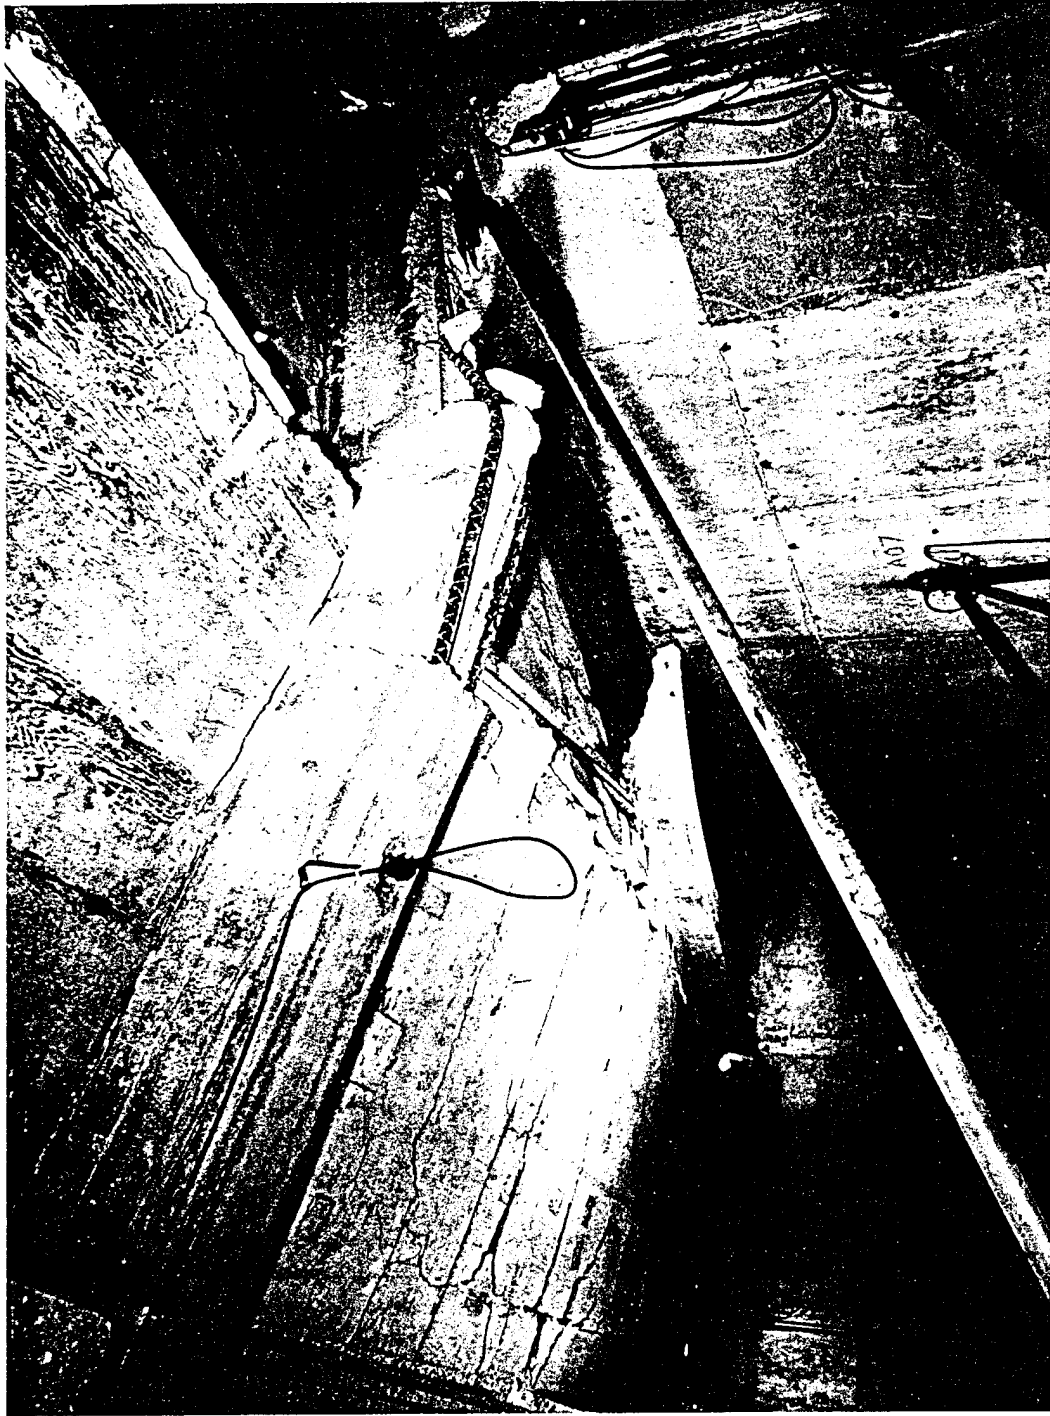
Fig. L. 519 Detail View of Failure of Roof Girder, Structure 3.2. 7b. Note the failure of the small stringer beam in the background. The sharp bend in the roof slab can be seen in the upper right-hand corner of this photograph.

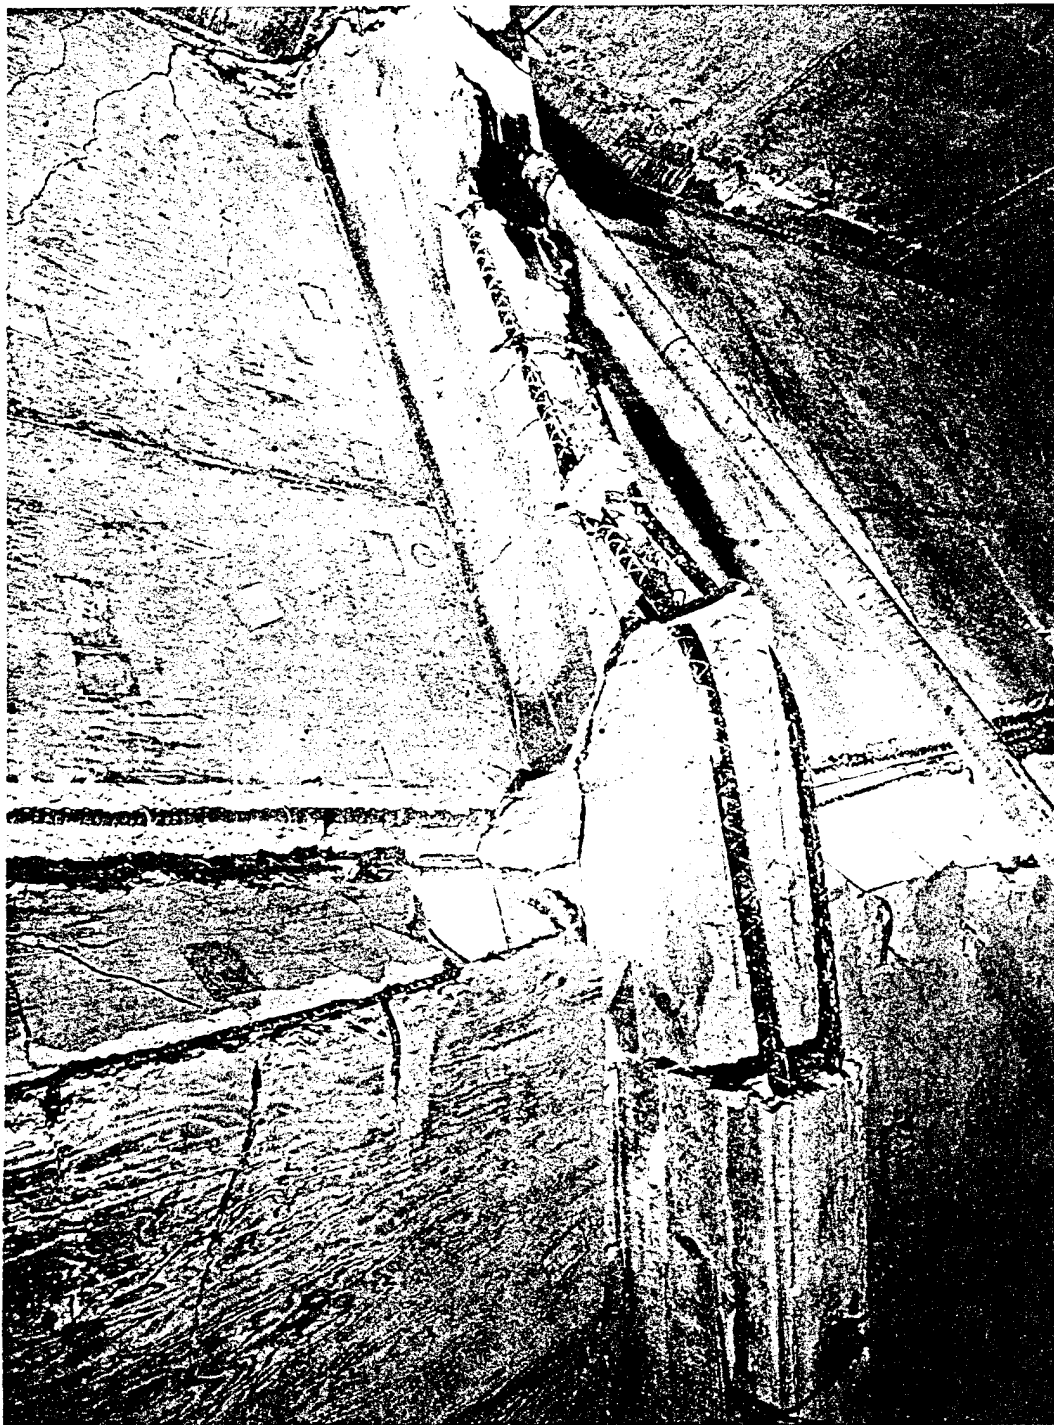
Fig. L. 520 Detail View of Portion of Roof Girder That Failed in Diagonal Tension and Then Telescoped Slightly
Until the Steel Restrained Further Motion, Structure 3.2. 7b

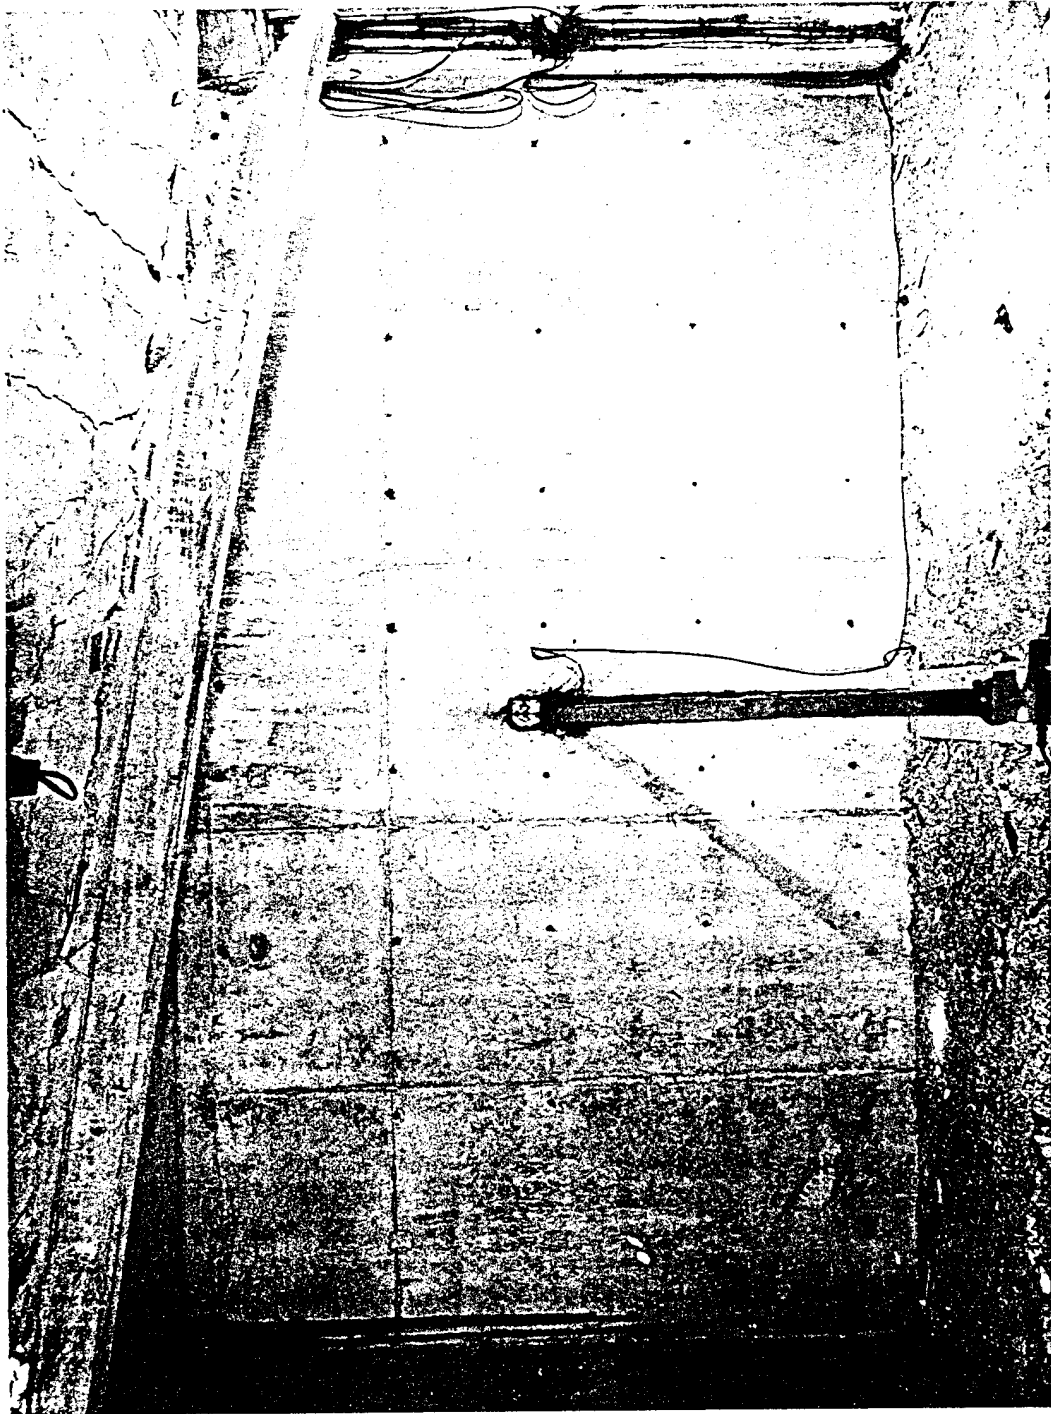
Fig. L. 521 Interior View of Right Half of Front Wall, Structure 3.2.7b. Slope of roof toward center and stringer beam can also be seen.

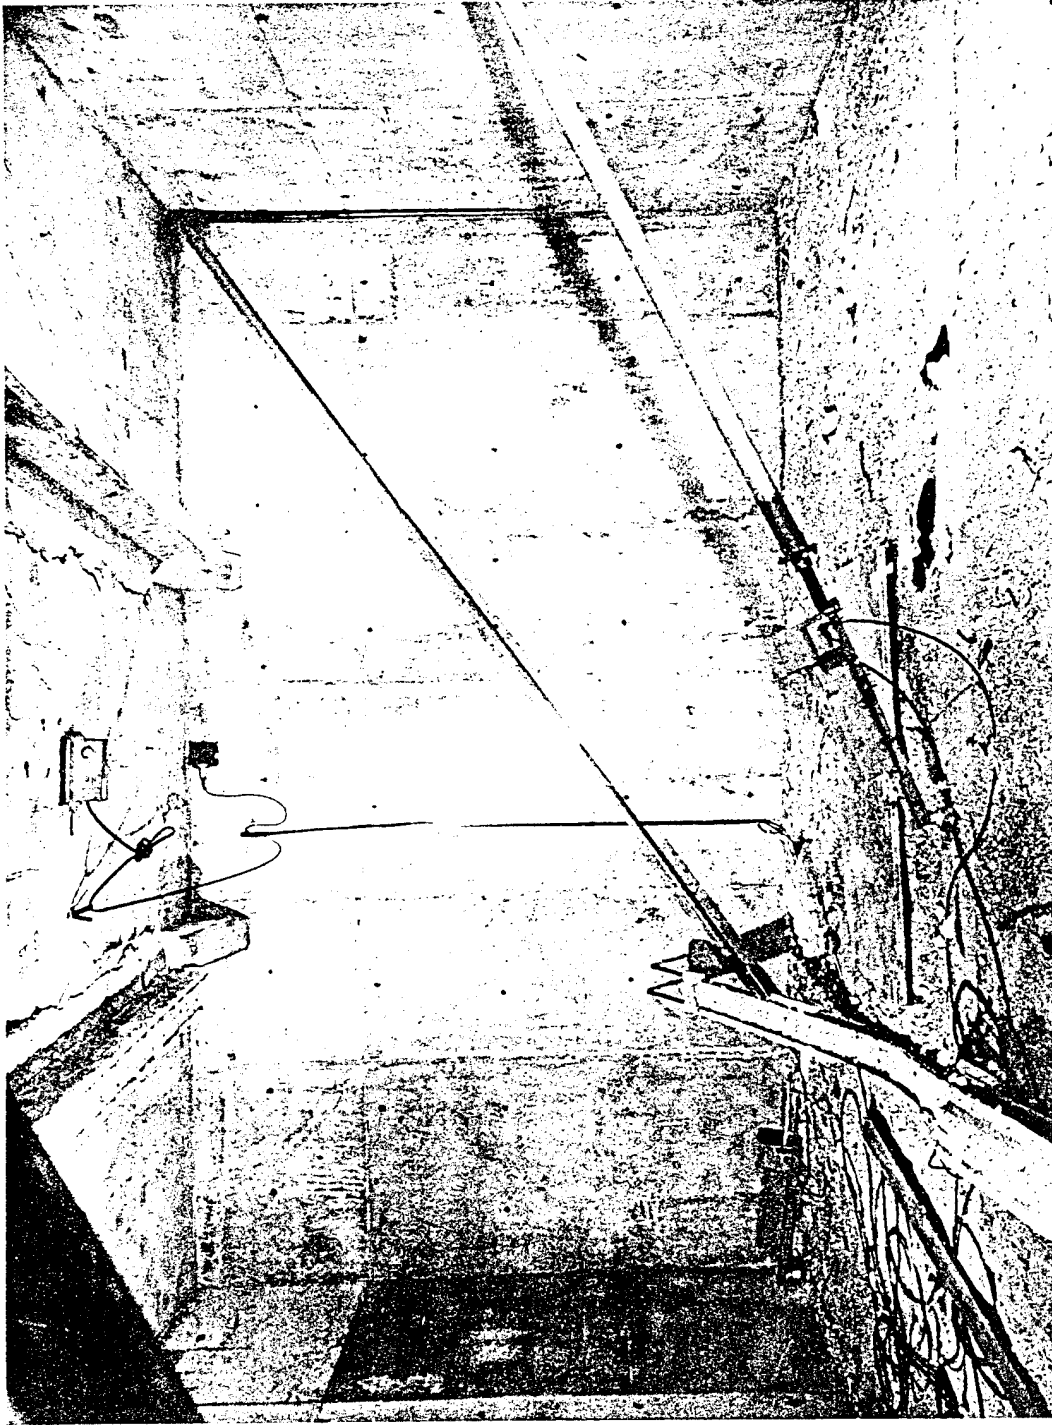
Fig. L. 522 Interior View of Right End Wall, Structure 3.2. 7b. Lower section of right rear stringer beam is shown lying on the ground.

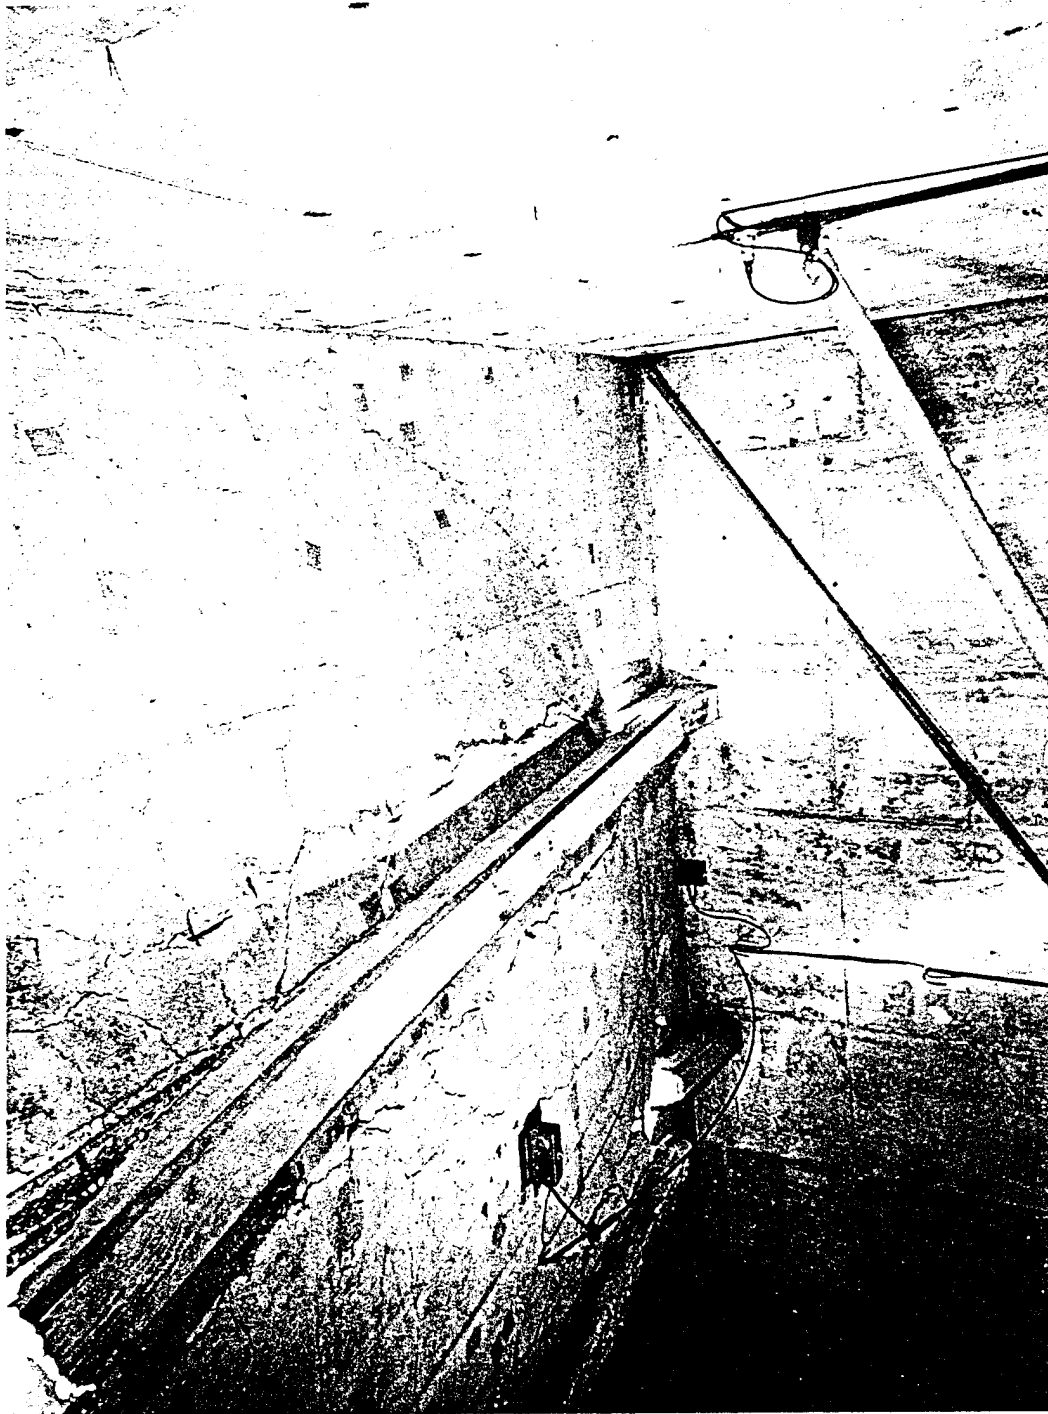
Fig. L. 523 Interior View of Front Right Corner, Structure 3.2.7b. Note the elliptical pattern of roof slab fracture; this is typical of entire roof.
